Aviation Investigation Preliminary Report

Location:	Denver, CO	Accident Number:	DCA25FA159
Date & Time:	March 13, 2025, 17:59 Local	Registration:	N885NN
Aircraft:	Boeing 737-823	Injuries:	12 Minor, 166 None
Flight Conducted Under:	Part 121: Air carrier - Scheduled

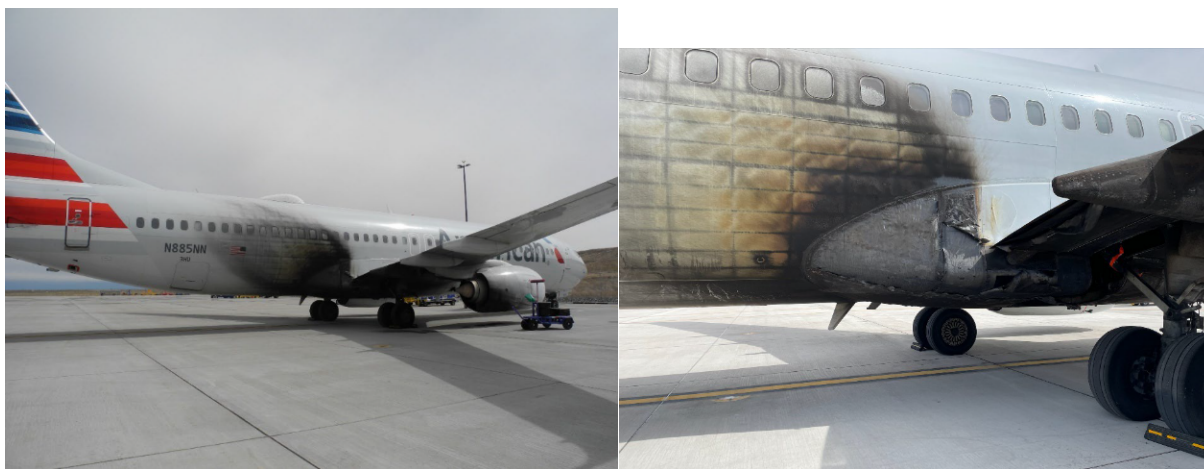
The airplane was towed to a local maintenance hangar for examination. The airplane exhibited heat/smoke/burn indications near the right engine nacelle, right wing, right side of the fuselage aft of the wing, the right main landing gear, and the right main landing gear wheel well (see figure 1).

Figure 1. Photos showing the damage to the right side of the airplane.

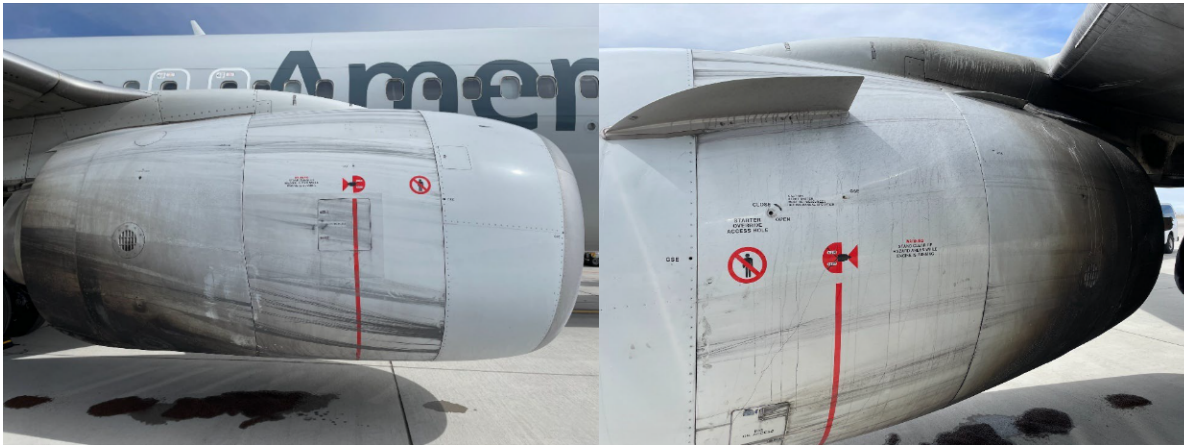
The on-scene engine examination found the right engine nacelle was intact; however, there was dark streaking which was consistent with in-flight streamlines and the aft and bottom of the nacelle was sooted and thermally distressed, consistent with a ground fire (see figure 2).

Figure 2. Photos showing the markings and damage to the right engine nacelle. The photo on the left shows the outboard view and the photo on the right shows the inboard view.
